Cheap Hummer Tricks - Aug 2004

This month's Cheap Tricks: Reinforcing the H2 Tie Rod.

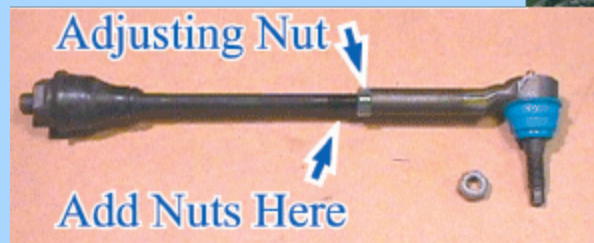
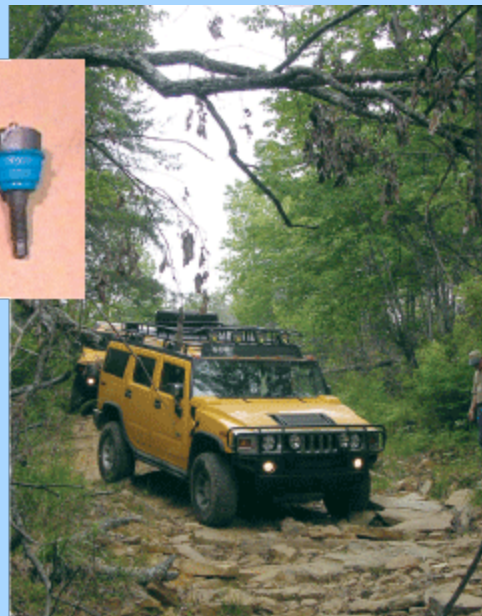
One of the few weak spots in the H2 is the Tie Rod. Any part can be broken with heavy or inappropriate usage, but the Tie Rod on the H2 seems to bend just a bit too easily. There are aftermarket replacement H2 Tie Rods. They are much stronger, but will likely void the factory warranty on the steering system. They work very well, but many owners are reluctant to risk loss of warranty coverage. It is likely that GM is developing something to address this problem. I have no information about this possibility, but I know that I would be if I were making these trucks. Today's Cheap Trick is a way to make the Tie Rod just slightly more resistant to bending. It is unlikely to affect anyone's warranty, but remember that GM has the final word on warranty issues. You should check with GM or your dealer before making any modification to warranted systems on your H2.

Picture 1 – Battery Terminal with Cover The trick: The inner Tie Rod is threaded for some distance to allow full adjustment for the front end alignment. Most (but not all) Tie Rod failures occur in this area. Placing additional nuts on this threaded section should make the Tie Rod slightly stronger. Picture 1 shows the factory adjusting nut, and the recommend location for the new nuts. Two or three nuts are usually all that will fit.

1. Raise the front tire with a jack
2. Determine how many nuts can be placed on the rod without interfering with the adjusting nut
3. Loosen the adjusting nut
4. Unthread the inner tie rod from the outer • Keeping the toe alignment adjustment is very important – count the number of turns required to separate the Tie Rod Ends
5. Remove the factory adjusting nut
6. Add the appropriate number of extra nuts – do not tighten at this time
7. Reinstall the factory adjusting nut
8. Reconnect the tie rod ends – thread them together the same number of turns counted in Step 4
9. Tighten the adjusting nut against the outer Tie Rod – tighten to 50 lb-ft
10. Tighten the extra nuts • Tighten the first against the adjusting nut • Do not allow the adjusting nut to move – it must remain tight against the outer Tie Rod End • Tighten each nut in turn against the previous

one You may wish to have the alignment checked following this procedure to make sure nothing was accidentally changed. This procedure can also be done when replacing the tie rod. The nut size is 14 x 1.5 (metric). The wrench required for this size nut is 22mm. A 13mm wrench is required to turn the inner Tie Rod End.
